# POLISH CONSERVATORS-RESTORERS IN ZHOVKVA CASTLE, UKRAINE

Sylwia Pawelkowicz<sup>1</sup> • Petr Svora<sup>2</sup> • Pavla Bauerová<sup>3</sup>  
Michał Witkowski<sup>4</sup>

Zhovkva Castle (Western Ukraine) together with the city of Zhovka was founded in 1597 by Stanislaw Zolkiewski. At the end of the 17<sup>th</sup> century, his great-grandson Jan Sobieski, the future king of Poland, made the Zhovkva Castle his official residence. In 2011, Polish conservators-restorers discovered wall paintings that presumably are contemporary to Zolkiewski. Accompanied by thorough material studies (OM, petrographic study, SEM/EDS/WDS, FTIR,  $\mu$ -XRD, nano-LC-ESI-Q-TOF), a detailed digital documentation, including the orthophotographs, and some emergency conservation works have been performed. The painter's palette consisted of calcite, white lead, massicot, red lead, vermilion, malachite and an expensive smalt with high concentration of cobalt. In blue areas, casein binder was identified, while in the red ones – egg and animal glue. To date the wall-paintings, a <sup>14</sup>C method was applied and a stylistic analysis has been performed. Art historical and archival studies helped to inter

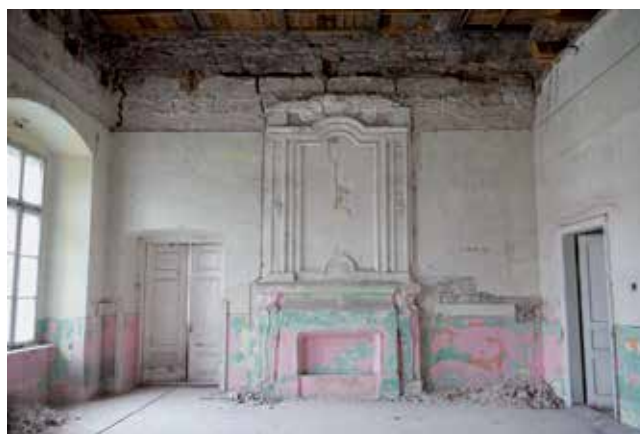
Fig. 4 Photo of the lime mortar chimneypiece in the room II. Test windows in the chimneypiece with well preserved fragments of the decoration. Phot. W. Holnicki

The lime mortar chimneypieces were built in the 18<sup>th</sup> century. At that time the ceilings were lowered and the nails, which were holding the structure of the new ceilings, were hammered into the upper part of the painted 17<sup>th</sup> century frieze. Although it suffered from permanent and irreparable damage, this operation it from being covered with new plasters. The lower part of the friezes has been practically removed. Only some remnants survived in the typical hard to reach places, such as corners, where the likelihood of surviving historic decoration is always assumed to be high. Since during the construction of the new steel roof truss in the 20<sup>th</sup> century, the ceilings in the palace were damaged, we could see some fragments of the paint layer. These small areas of painted decoration went completely unnoticed by the current users of the building. It is mainly because, due to the poor state of preservation, this part of the castle is not visited.

In 2013, in order to assess the scope of the painting and especially the bottom part we executed test windows in the lime mortar chimneypieces. The preservation of the paint layer in this place turned out to be much better. The layers of gypsum protected it from the influence of external conditions. Still the lime mortar chimneypieces are of historical value as they were executed in 18<sup>th</sup> century. The last phase consisted of dismantling the chimneypieces and executing a thorough recording of the findings. The original plan was to recover the paintings and reinstall the dismantled pieces of chimneys. Due to the decision of the owner of the castle, the dismantled pieces were described, documented and put together in the storage rooms of the museum. The museum is now working on a project of a new exhibition and the chimneys will probably be moved in order to show the discovered paintings: the portraits of a man and a strapwork ornament. This last element of our puzzle was indeed necessary to produce good documentation, including orthophotographs, with all the gathered information, and studies, accessible on the internet website. The database is already built and the website is to be launched in the near future.

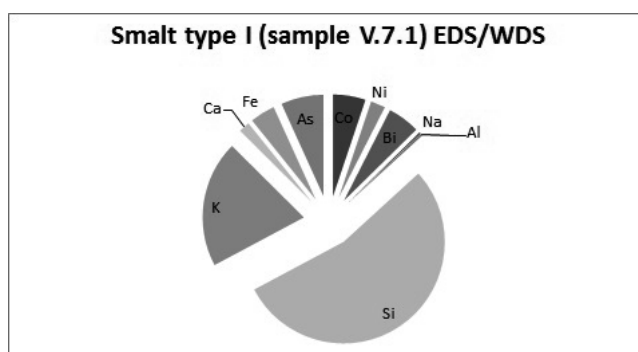
Fig. 5 Averaged elemental composition of the dark blue smalt from EDS/WDS measurements

Smalt was identified in two different rooms (rooms II and V versus room IV), in two different paintings. The elemental composition of the pigments was however completely different. Different ratios or absence of trace element might indicate the origin of the raw material used or methods of production. In the dark blue smalt, with a colour that nearly looked like ultramarine, less silica, more cobalt, and intensive peaks from bismuth and nickel were detected. While the light blue particles contained minor quantities of cobalt, zinc and nickel, whereby bismuth was only detectable with WDS detector. In the dark blue smalt the average quantity of cobalt was 5.23 % (WDS) and 5.66 % (with EDS), while in light blue 1.84 % (WDS) and 1.52 % (EDS).

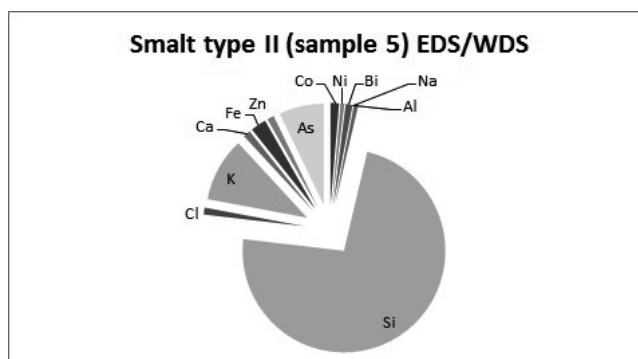
Fig. 7 Averaged elemental composition of the light blue smalt from EDS/WDS measurements

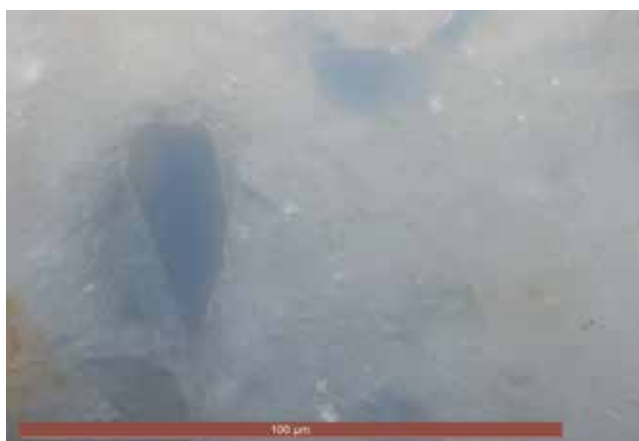
Fig. 8 Microscopic photography of light blue smalt. Phot. S. Pawełkowicz.

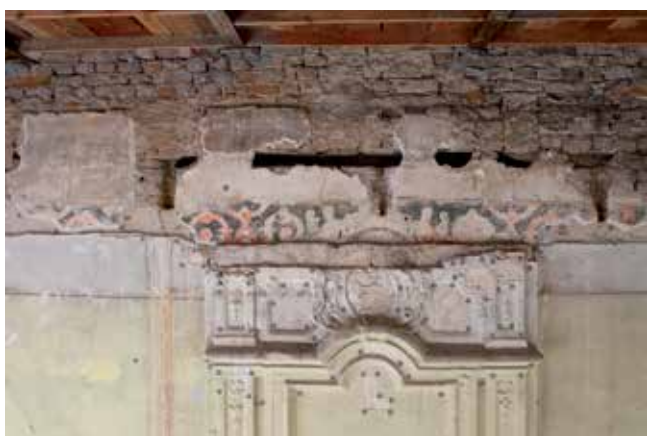
Fig. 9 Fragment of the frieze in room V uncovered in 2013. Phot. W. Holnicki

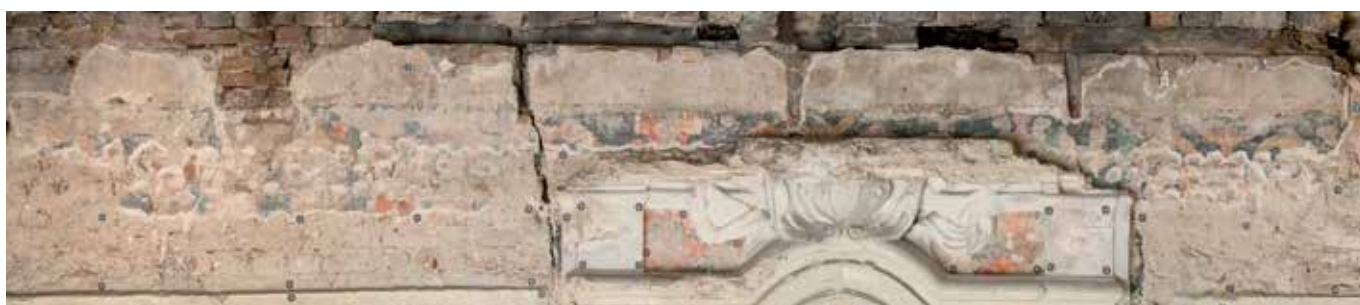
Fig. 11 Uncovered frieze in room II. State from 2013. Test windows in the chimney piece. Phot. W. Holnicki
